Quality Assurance and Source Inspection

Contract #: 04-0120F4Cty: SF/ALA Rte: 80 PM: 13.2/13.9File #: 1.28**WELDING INSPECTION REPORT****Resident Engineer:** Siegenthaler, Peter**Address:** 333 Burma Road**City:** Oakland, CA 94607**Report No:** WIR-018863**Date Inspected:** 23-Dec-2010**Project Name:** SAS Superstructure**OSM Arrival Time:** 630**Prime Contractor:** American Bridge/Fluor Enterprises, a JV**OSM Departure Time:** 1500**Contractor:** American Bridge/Fluor Enterprises, a JV**Location:** Jobsite**CWI Name:** See below**CWI Present:** Yes No**Inspected CWI report:** Yes No N/A**Rod Oven in Use:** Yes No N/A**Electrode to specification:** Yes No N/A**Weld Procedures Followed:** Yes No N/A**Qualified Welders:** Yes No N/A**Verified Joint Fit-up:** Yes No N/A**Approved Drawings:** Yes No N/A**Approved WPS:** Yes No N/A**Delayed / Cancelled:** Yes No N/A**Bridge No:** 34-0006**Component:** SAS OBG**Summary of Items Observed:**

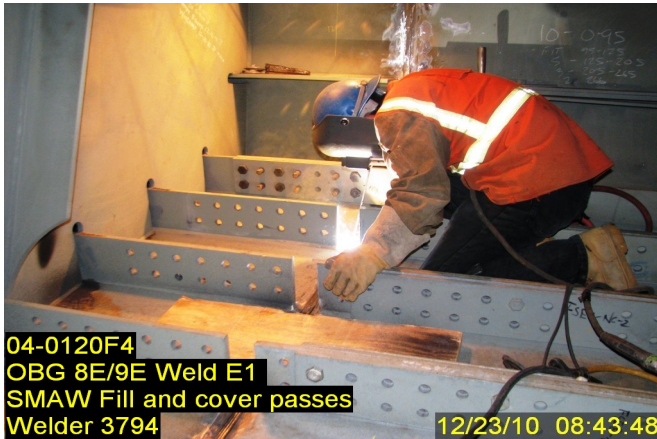
The QAI periodically observed AB/F approved welder Song Tao Huang (ID 3794) performing welding of fill and cover passes at the 1st 1000mm of OBG Field Splice 8E/9E Weld E1. See photo below. The welding was performed per the Shielded Metal Arc Welding (SMAW) process in the 3G (vertical) position. The QAI observed QC Inspector Fred Von Hoff were present periodically to monitor the progress and verify that the welding parameters were within the limits established by the approved welding Procedure Specification (WPS) identified as ABF-WPS-D1.5-1040A. The welding of fill and cover passes was in process. The QAI observed that the work at this location appeared to be in general compliance with contract documents.

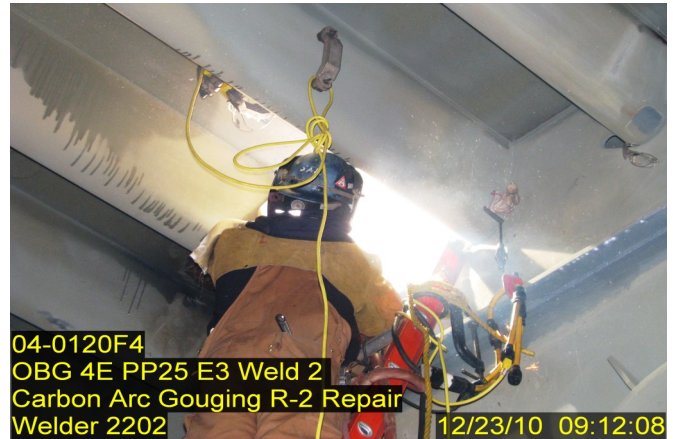
Interior: OBG 4E PP25 E3 weld 2

The QAI periodically observed AB/F approved welder Salvador Sandoval (ID 2202) performing air carbon arc back gouging & back grinding of (2) two R-2 UT repairs at OBG 4E PP25 E3 weld 2. See photo below. The QAI did not observe repair welding at this location on this date. The QAI observed that the work at this location

appeared to be in general compliance with contract documents.
